OWL MORTALITY ON FENCES AND UTILITY LINES

by Richard E. Fitzner Ecosystems Department Battelle Northwest Laboratories Richland, Washington 99352

ABSTRACT. McCarthy (Wilson Bull. 85:477-478) and Edeburn (Wilson Bull. 85:478) discuss unusual deaths of Great Horned Owls due to collisions with barbed-wire fences. This report describes the wire-caused deaths of three Short-eared Owls (*Asio flammeus*) and one Great Horned Owl (*Bubo virginianus*) in southeastern Washington and adjacent Idaho during the winter of 1973-74.

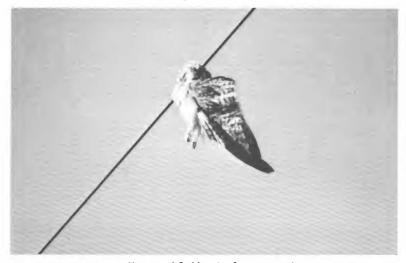
On 1 February 1974 three miles southwest of Pullman, Washington, a dead Great Horned Owl was found entangled in the top wire of a two-barb barbed-wire fence (Fig. 1). The bird was carefully untangled to obtain some clue as to how the accident occurred. A single barb had pierced the skin and muscle within one inch of the distal end of the radius and ulna. The momentum of flying apparently flipped the bird over the top strand, further entangling the wing on both barbs. No bones were broken.

Fig. 1. Great Horned Owl impaled on a two-barb barbed-wire fence

The Great Horned and Short-eared Owls found impaled on barbed wire fences are interesting cases. These birds were hunting in bare plowed fields. The only habitat available to their prey (small rodents) was narrow weedy corridors along fence rows or areas too steep or too rocky for cultivation. In such situations the owls were constantly confronted with barbedwire fences. If they had no prior experience with such fences (i.e., birds of the year or ones raised in areas lacking fences), they might simply have perceived the fences as movable vegetation which would have caused insignificant disruption to their flight.

The frequency of wire-collisions by owls remains an open question. However, it may be worthwhile to identify trouble spots where one or more mishaps have occurred and to work out some plan to reduce or eliminate future accidents. For example, old, unused barbed-wire fences could be removed. Fences in use could be marked with strips of ribbon or foil to increase their visibility.
